# Manhole Inspection Summary

Manhole # S41A2\_011MH

Insp Date: **4/22/08 1:02 PM**

**Location** Address: **801 E. Pontiac Ave.**

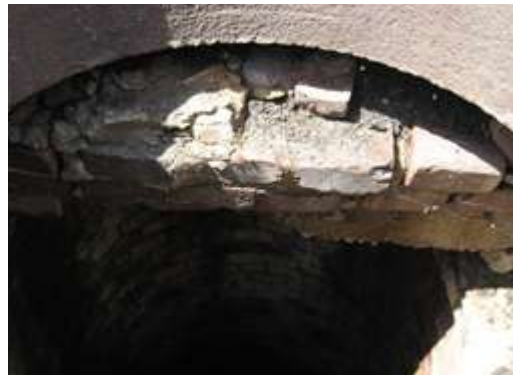
Defect 1

Condition: ☐ Sound ☒ **Cracked** ☐ Root Intrusion ☐ Loose Brick ☐ Deteriorated

Infiltration: ☐ None ☒ **Joint** ☐ Cracks ☐ Mortar ☐ Roots ☐ Wall

Loose bricks at Chimney

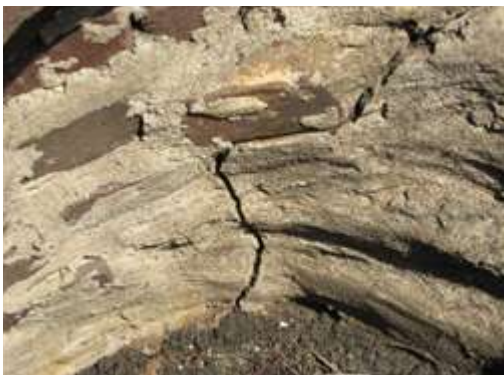
Defect 2

Cracks at Chimney

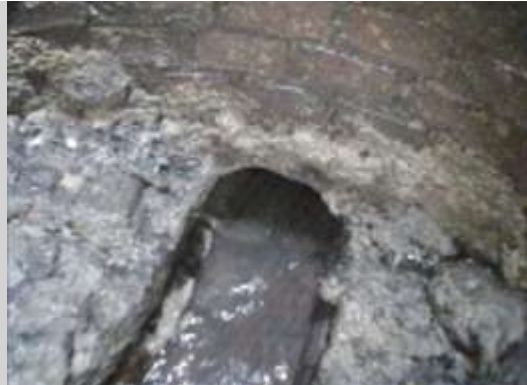
12 O'Clock Outflow

8 in. Circular Gravity Sewer  
Pipe Out @ 12 O'Clock

Pipe Height: **9.6** (in.) Rod and Bar (Angled)  
Pipe Material: **Clay** ☐ Pipe Lined  
Invert Depth: **15.20** (ft.) Flow Characteristics: **Fast**  
Deposits: ☒ None ☐ Mud ☐ Sludge ☐ Debris ☐ Grease  
Silt Depth: (in.) Deposits Extent:  
Infiltration: **None** Pipe Seal Cond: **Sound**

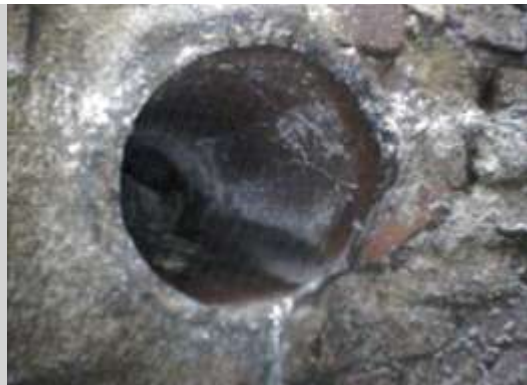
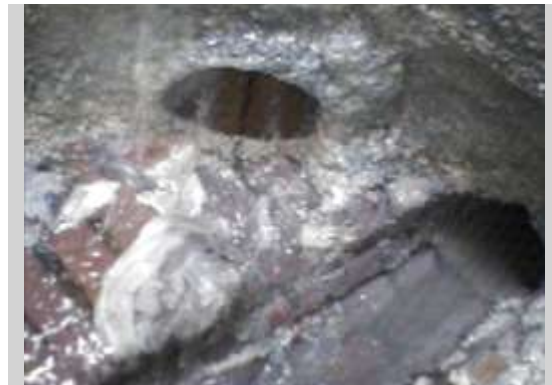
5 O'Clock Inflow

8 in. Circular Gravity Sewer  
Pipe In @ 5 O'Clock

Pipe Height: **8.4** (in.) Rod and Bar (Angled)  
Pipe Material: **Clay** ☐ Pipe Lined  
Invert Depth: **11.70** (ft.) Flow Characteristics: **Fast**  
Deposits: ☒ None ☐ Mud ☐ Sludge ☐ Debris ☐ Grease  
Silt Depth: (in.) Deposits Extent:  
Infiltration: **None** Pipe Seal Cond: **Sound**

Drop: **Outside** Rod and Bar  
Angled: **Yes** Reading: **13.40** (ft.)  
Inv Depth: **14.40** (ft.)

Drop Condition: **Open**

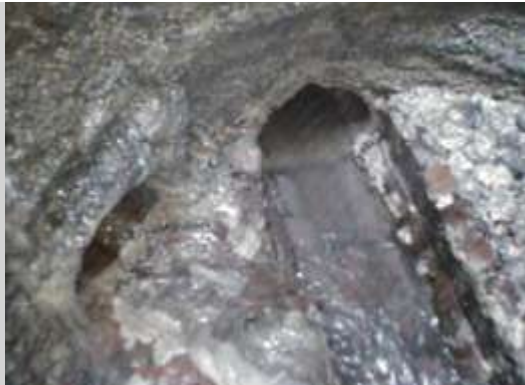
7 O'Clock Inflow

Pipe In @ 7 O'Clock

Pipe Height: **8.4** (in.) Rod and Bar (Angled)

Pipe Material: **Clay** ☐ Pipe Lined

Invert Depth: **15.10** (ft.) Flow Characteristics: **Fast**

Infiltration: **None** Pipe Seal Cond: **Sound**
